Manhole Inspection Summary

Manhole # S13KK1019MH

Location Address: **4650 PALL MALL RD**

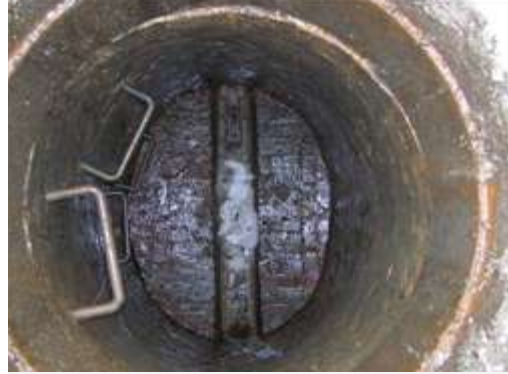
Top View

Bench ☒ Exists Material: **Brick** ☐ Parged ☒ **Debris** (not Condition related)

Bench debris. Channel debris.

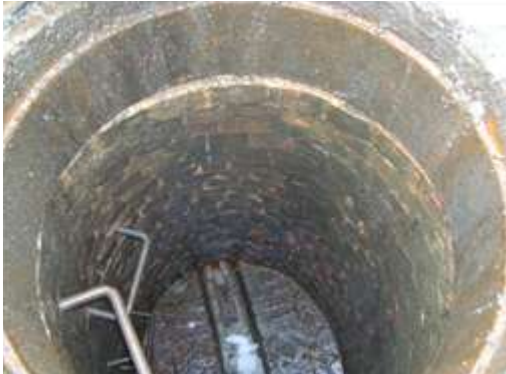
Defect

Frame Offset: **0** (in.) Condition: ☐ Sound ☐ Cracked ☒ **Leaks**

Infiltration: ☐ None ☒ **Joint** ☐ Cracks ☒ **Mortar** ☐ Roots ☐ Wall

Frame leaks. Adjustment infiltration - other side.

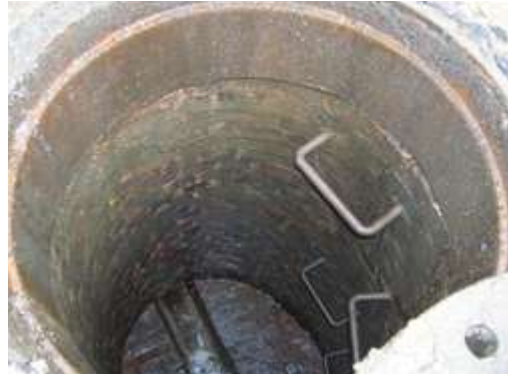
Defect

Frame leaks. Adjustment infiltration.

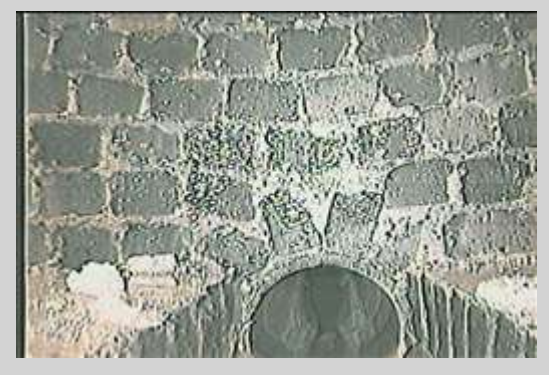
8 in. Circular Gravity Sewer Pipe Out @ 12 O'Clock

Deposits: ☐ None ☐ Mud ☐ Sludge ☐ Debris ☒ **Grease**

Silt Depth: **0** (in.) Deposits Extent: **Light**

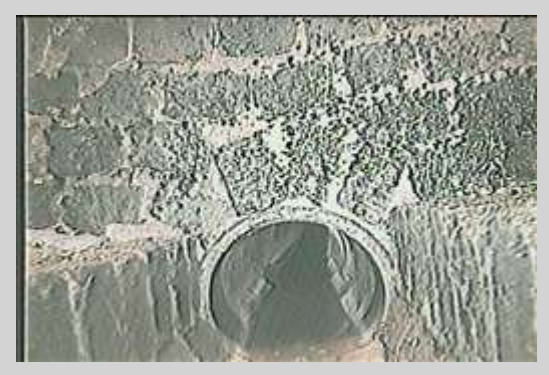
8 in. Circular Gravity Sewer Pipe In @ 6 O'Clock

Deposits: ☐ None ☐ Mud ☐ Sludge ☐ Debris ☒ **Grease**

Silt Depth: **0** (in.) Deposits Extent: **Light**
